INDOOR AIR QUALITY ASSESSMENT

**Augustine Belmonte Middle School
25 Dow Street
Saugus, Massachusetts**

Prepared by:
Massachusetts Department of Public Health
Bureau of Environmental Health Assessment
Emergency Response/Indoor Air Quality Program
January 2003

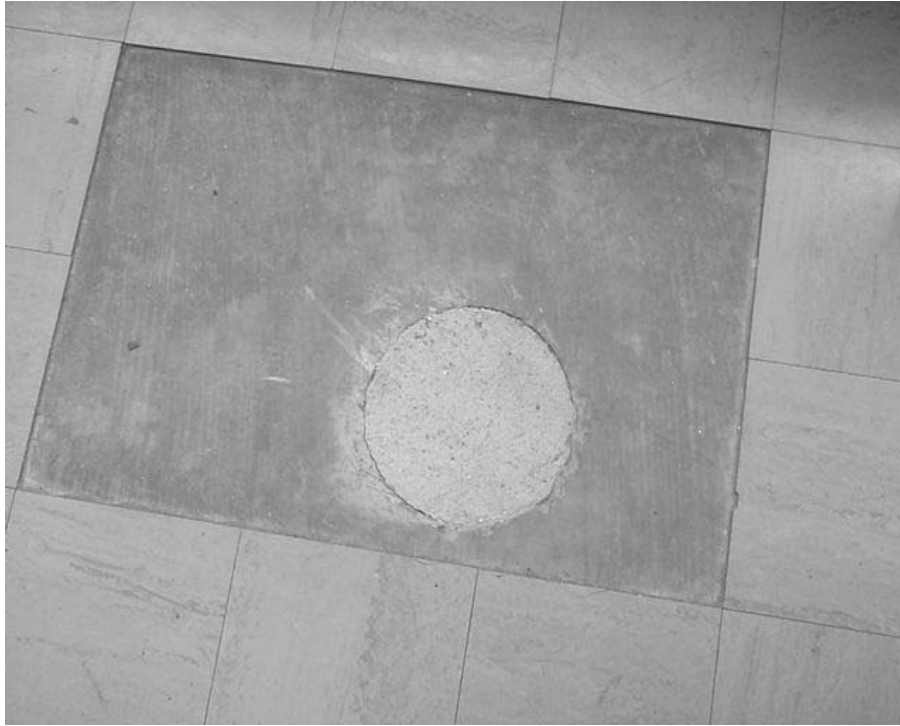
Picture 1

The school took additional steps to remove pipes and other utilities from the crawlspace and fill it with concrete to form a slab (see Picture 1). Pipes and other utilities were installed along the ceiling of first floor classrooms (see Picture 2). OccuHealth retested the crawlspace as well as a number of classrooms in September of 2002 following remedial actions and found mold levels in all areas below background (OccuHealth, 2002).

Former Utility Pipe Holes Filled with Concrete

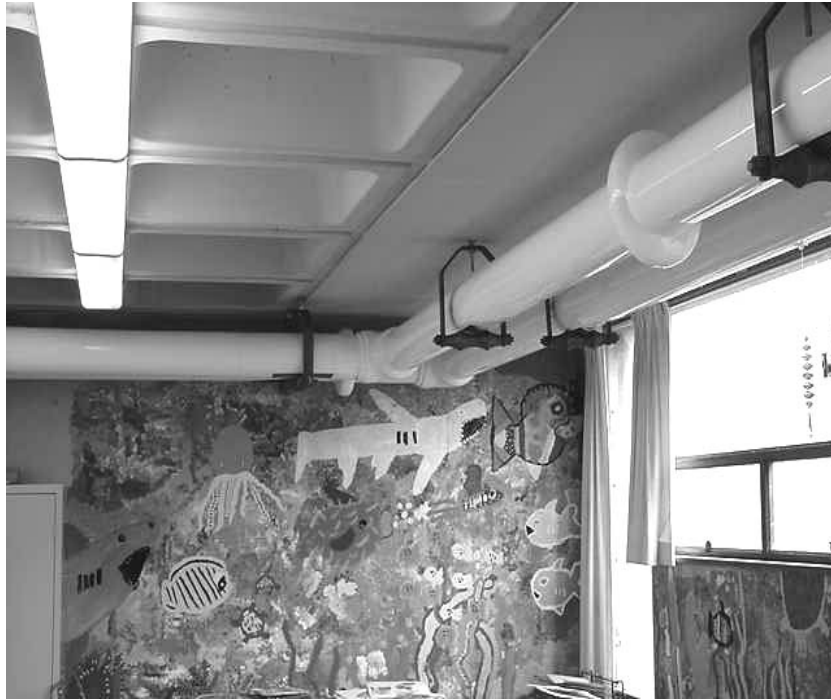
Picture 2

New Installed HVAC System Pipes

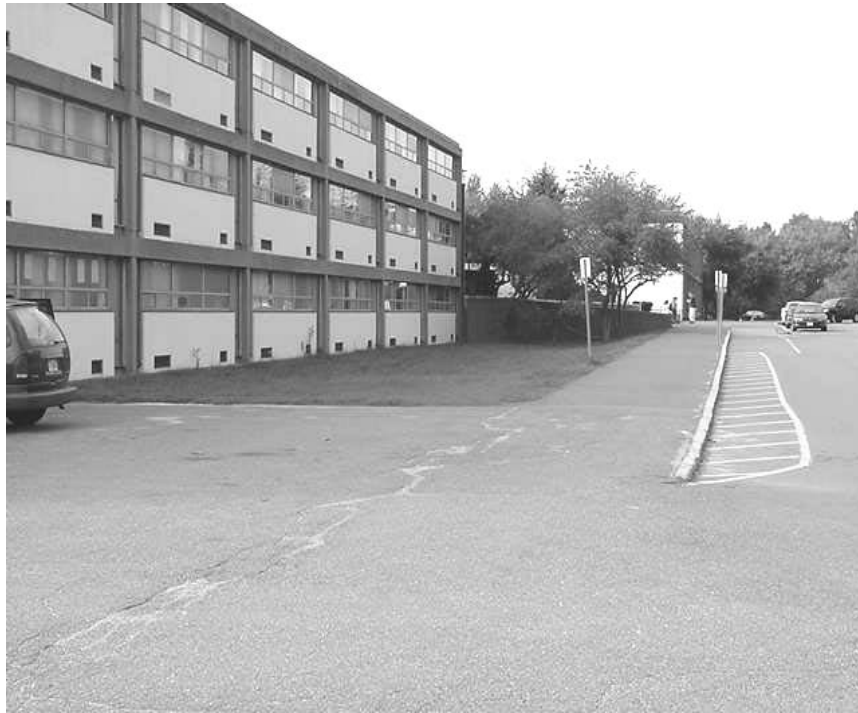
Picture 3

Several conditions were observed which appear to enhance water impact upon the south wing. The front of the building has a driveway and is several feet above the level of the lowest floor of the south wing. Land between the driveway and south wing slab *slopes toward* the building (see Picture 3). Water appears to accumulate in a corner formed by the south wing and the front walkway of the building (see Picture 4) coming in contact with the slab as indicated by the lack of grass growing in the corner as well as along the foundation/slab. Several other features tend to enhance the collection of water in this corner.

Over time, these conditions can undermine the integrity of the building envelope and provide a means of water entry into the building through capillary action through foundation concrete and masonry (Lstiburek & Brennan, 2001). This may also allow for water to gather beneath the slab.

Front Lawn of South Wing the Slopes toward the Foundation

- c. Consideration should be given to re-grading the front lawn and lowering the level of storm drain to enhance drainage should be considered.
 - d. Install a water impermeable layer on ground surface (clay cap) to prevent water saturation of ground near foundation (Lstiburek, J. & Brennan, T.; 2001). This may include paving over the small lawn at the rear of the south wing.

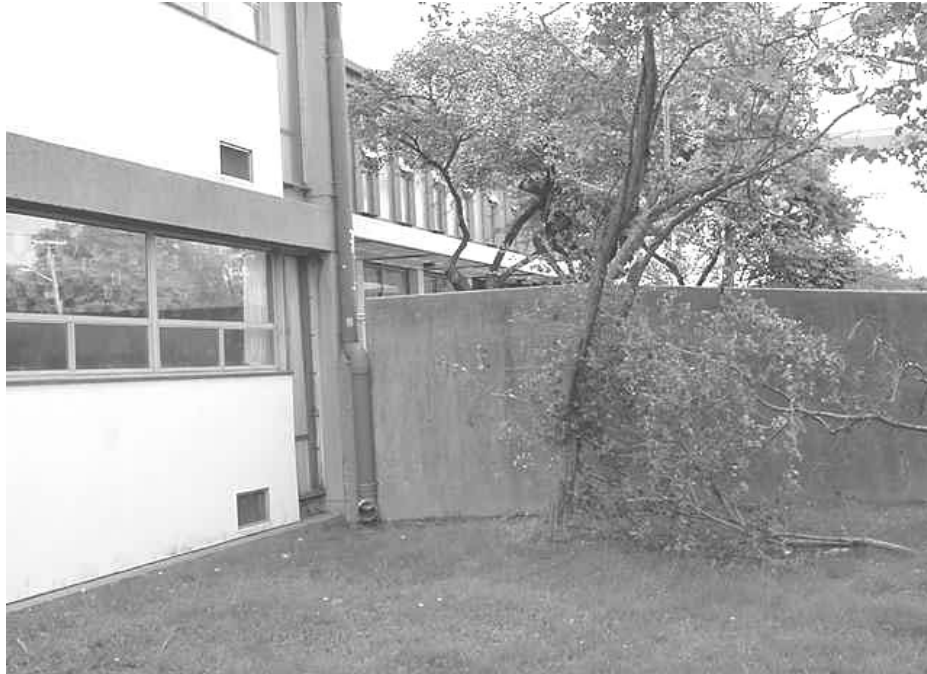
Picture 4

1. A downspout that serves as a roof drain empties directly into the corner (see Picture 4),
2. Several trees grow in this corner (see Picture 4). Plant roots tend to accumulate water. Tree roots that extend from the trunk can serve a conduit for water to travel. The presence of trees can both hold water in and direct water towards the foundation.
3. While a drain is located within this lawn (see Picture 5), it is above the lowest point of this area.

Corner of Front Lawn Prone to Water Accumulation, Note Downspout and Locate of Trees

- e. Remove the accumulated materials beneath the guardrail to enhance water drainage.
- 5. Examine the feasibility of extending downspouts to ground level and directing water away from the base of the exterior wall.

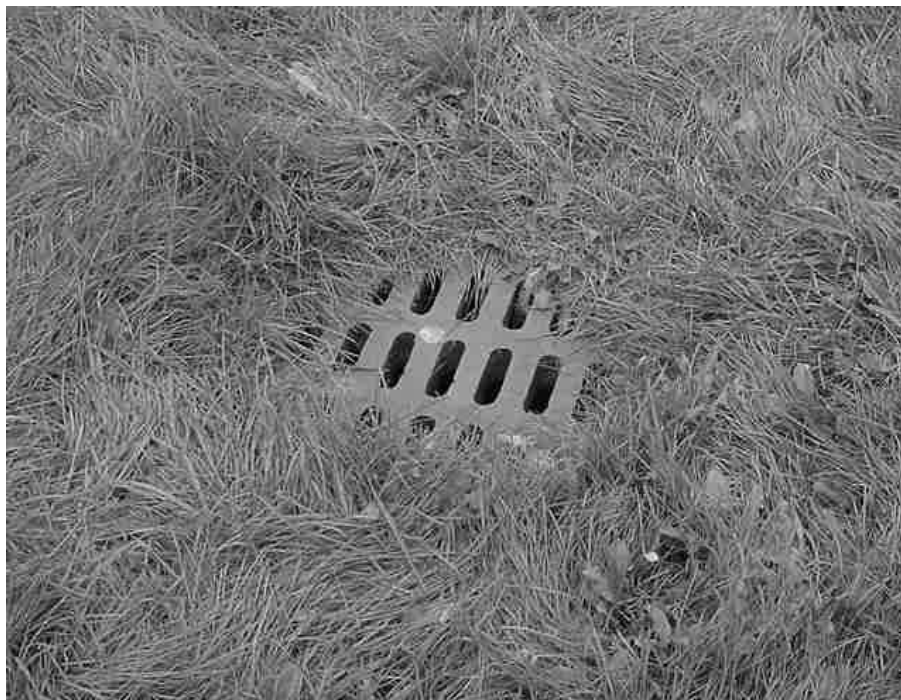
Picture 5

Front Lawn Drain Overgrown by Grass

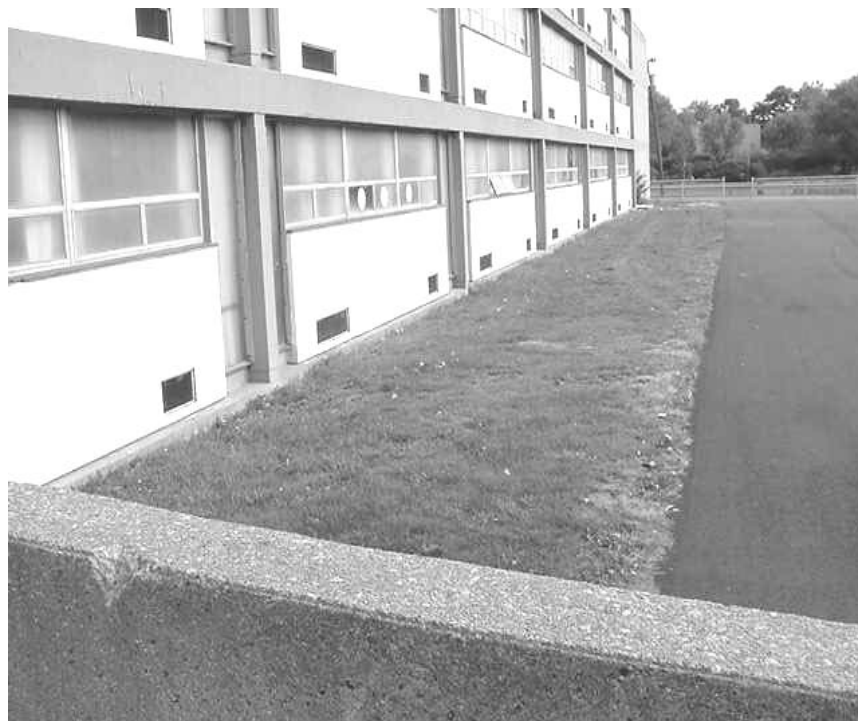
Picture 6

A similar condition exists along the rear exterior wall of the south wing. A small lawn exists immediately adjacent to the slab (see Picture 6). Moist weather tends to

travel in a northeasterly track up the Atlantic Coast towards New England (Trewartha, G.T., 1943). Wet weather systems generally produce south/southwesterly winds, which will directly strike the west exterior wall of the south wing. Rainwater runoff from the west exterior wall runs onto this lawn and pools. Over time, the impact of water has eroded soil, creating depressions in the grass that accumulate water (see Picture 7). Enhancing water accumulation is another roof drainage downspout that empties onto this lawn (see Picture 8). No drains exist in this lawn area. The closest drain is located over one hundred feet west of the south wing in a ball field (see Picture 9). While the tarmac is leveled towards this drain, away from the south wing, plant growth along a guardrail at the edge of a driveway between the drain and the school has created a berm, which prevents water drainage. The existence of lawns at the front of and behind the south wing combined with roof drains emptying near the foundation create conditions to allow water to pool against the foundation.

Small Lawn at Rear of South Wing

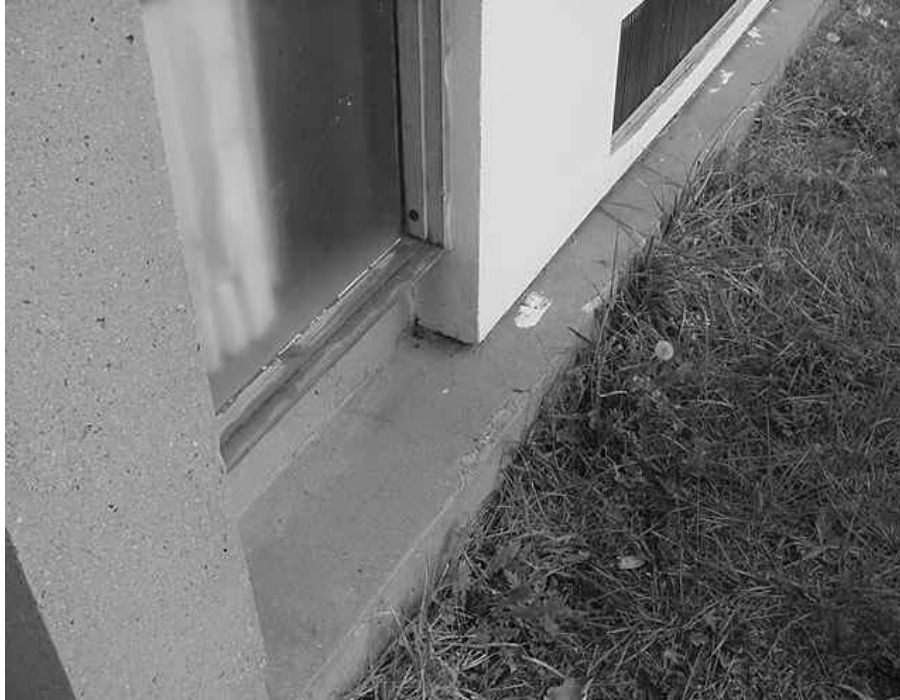
Picture 7

Water Furrowed Depressions along West Exterior Wall of South Wing

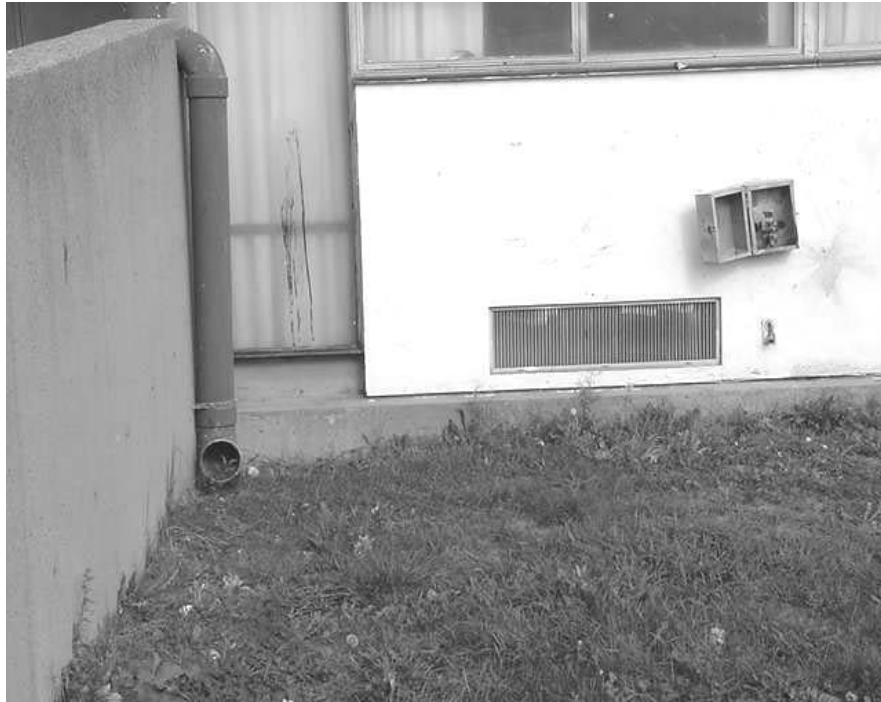
Picture 8

Downspout That Empties Onto Rear Lawn of South Wing

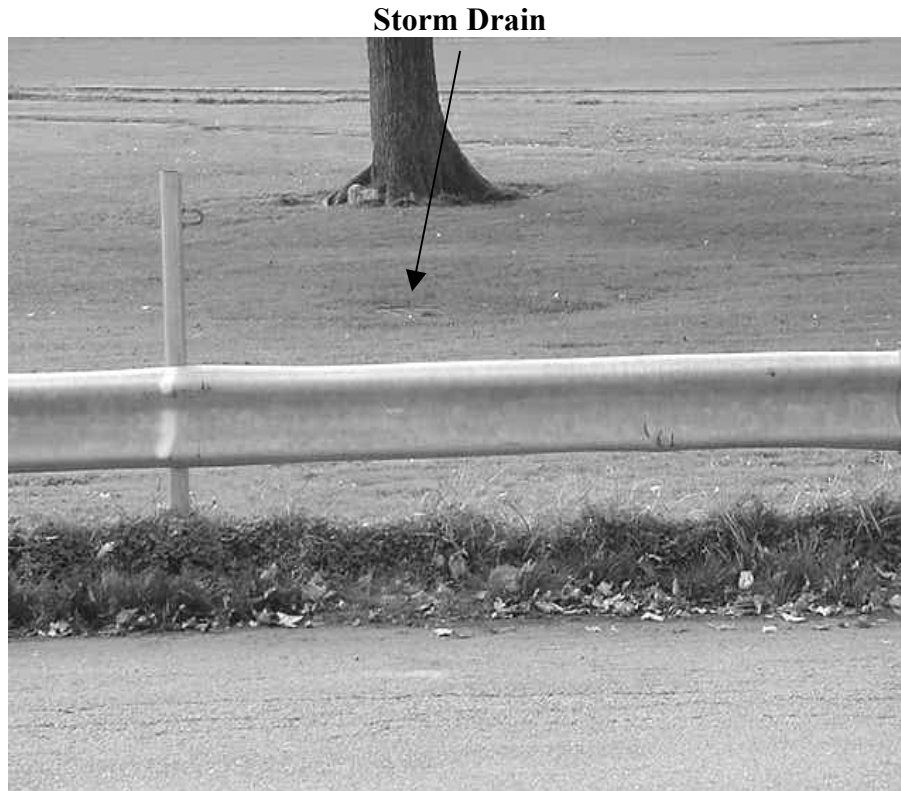
Picture 9

Storm Drain in Field, Note Berm Created by Vegetation below Guardrail, Creating a Dam

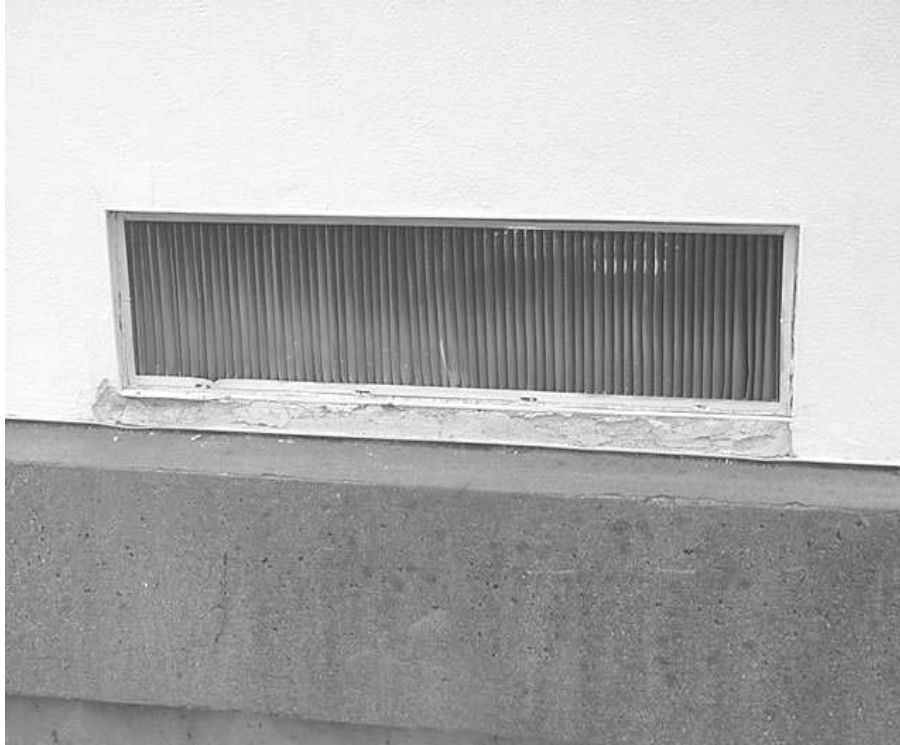
Picture 10

The west exterior wall of the south wing was also examined. It appears the rainwater striking the wall splashes onto the lip of the foundation, which extends several inches out from the line of the wall. Located at the base of the foundation are univent fresh air intakes (see Picture 10). The location of the fresh air intakes may make these vents prone to moisture exposure and accumulation of outdoor debris. The interior of univent fresh air intakes could not be examined since each grill was tightly caulked into place. If water moistens accumulated outdoor debris within the fresh air intake, this material may support mold growth.

Fresh Air Intake Vents at Base of South Wing West Exterior Wall, Note Water Damage at Base of Grille

- 6. Fresh air intakes at ground level should be opened and examined. Clean debris if present. Consideration should be given to installing a hood or other device over ground floor univent fresh air intakes to prevent rainwater intrusion.

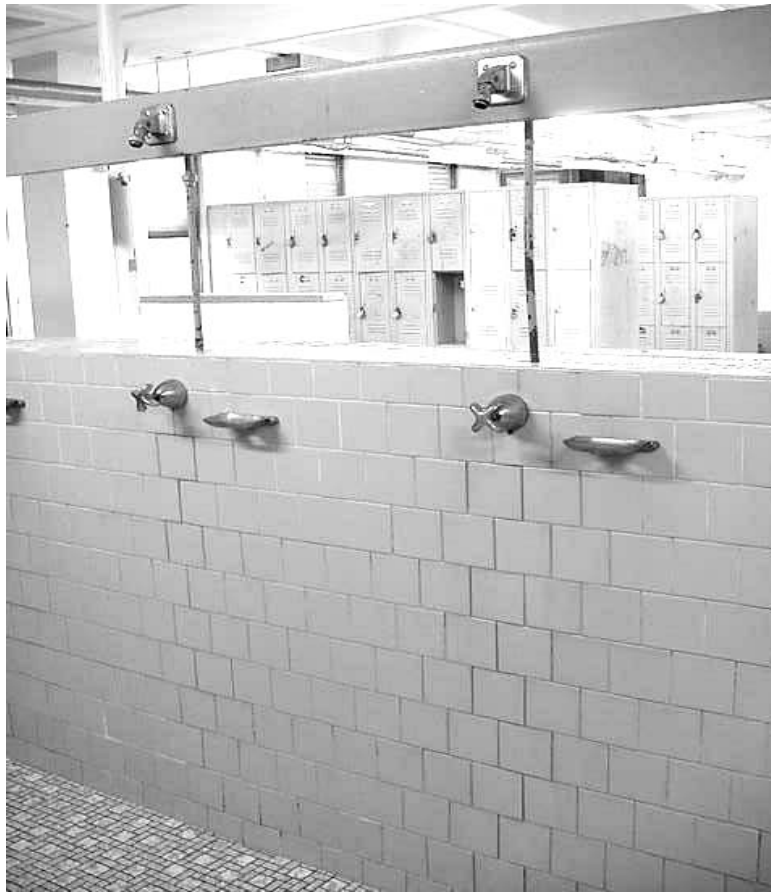
Picture 11

Active mold growth was observed on tiled walls in the shower area of the boy's locker room. The characteristic pattern on walls and the floor directly below indicate that

the showerheads are leaking (see Picture 11). Microbial growth can be a source of irritation for sensitive individuals.

Leaking Shower Heads and Mold Growth between Wall Tiles in Boy's Locker Room

14. Clean mold growth in shower areas and repair leaking shower fixtures. Ensure local exhaust vents are activated when showers are in use to remove excess heat and moisture.

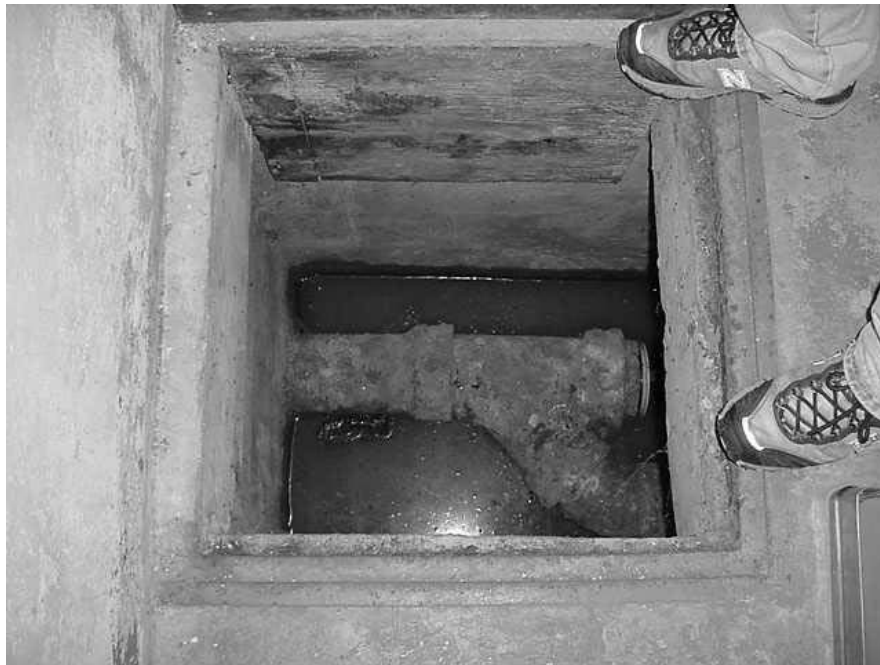
Picture 12

The crawlspace in the corner of the girl's locker room/shower area was examined. Several inches of standing water was observed and strong odors were detected upon opening the access plate (see Picture 12). Standing water can become stagnant, which can lead to mold, bacterial, or other microbial growth that can be a source of unpleasant odors.

Standing Water in Girls Locker Room Crawlspace

12. Unclog drain in rear entrance way and ensure proper drainage. Inspect periodically to maintain drainage.
13. Continue to examine methods to eliminate water accumulation in the crawlspace, or take measures to create an airtight seal between the crawlspace and occupied areas.

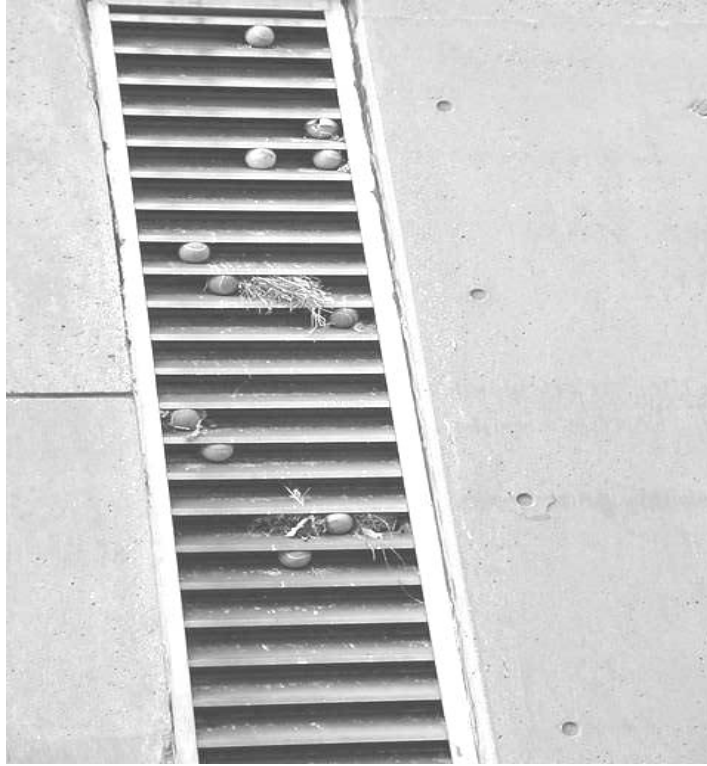
Picture 13

Signs of bird roosting and nesting materials were observed in the gymnasium air intake louvers on the exterior of the building (see Picture 13). If the ventilation system is activated, the possibility exists for nesting materials, bird waste and other related particulate to be drawn into the system and be distributed to occupied areas. Birds can be a source of disease, and bird wastes and feathers can contain mold and mildew, which can be irritating to the respiratory system.

Certain molds are associated with bird waste and are of concern for immune-compromised individuals. Other diseases of the respiratory tract may also result from chronic exposure to bird waste. Exposure to bird wastes is thought to be associated with the development of hypersensitivity pneumonitis in some individuals. Psittacosis (bird fancier's disease) is another condition closely associated with exposure to bird wastes in either the occupational or bird raising setting. While immune-compromised individuals have an increased risk of health impacts following exposure to the materials in bird wastes, these impacts may also occur in healthy individuals exposed to these materials.

Birds Nests and Wastes in Gymnasium Fresh Air Intake

11. Remove birds' nests from fresh air intake vents and clean with an appropriate antimicrobial. If bird nesting/waste contamination is determined to be extensive consider contacting a professional cleaning company. Consider installing wire mesh bird screens over gymnasium air intakes to prevent further roosting (see Picture 23).

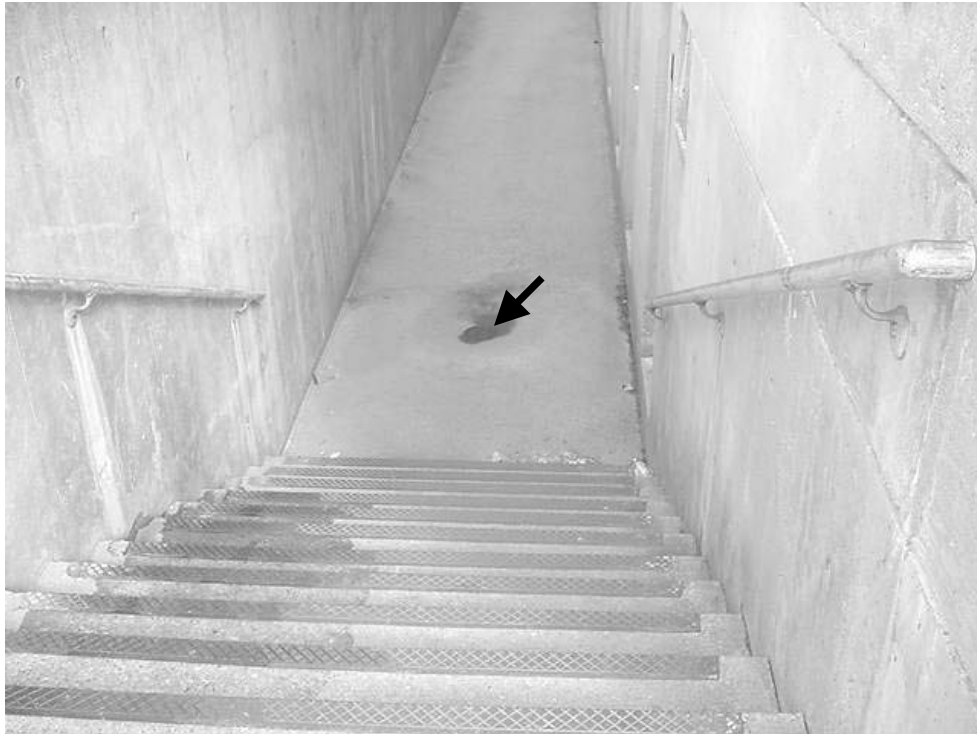
Picture 14

Reports of flooding in the rear stairwell were expressed to BEHA staff (see Picture 14). The drain located at the base of the stairwell was completely clogged with debris (see Picture 15). Also noted on the rear of the building were missing downspouts (see Picture 16). Gutters and downspouts are designed to collect rainwater and divert them away from the building. Improper drainage and/or missing downspouts can allow water accumulation against the building.

Rear Entrance Prone to Flooding, Arrow Indicates Drain

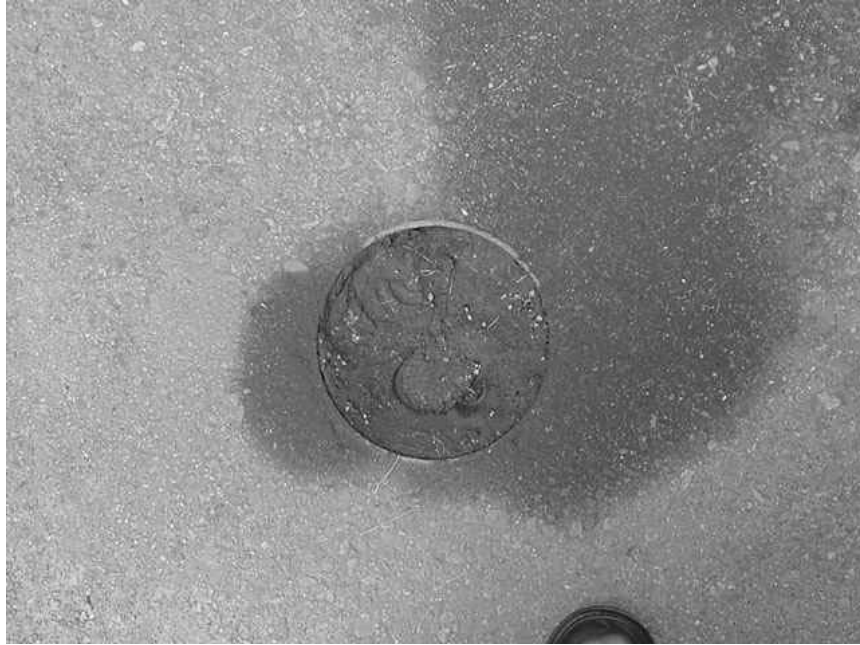
Picture 15

Close-Up of Clogged Drain (In Previous Picture) For Rear Entrance

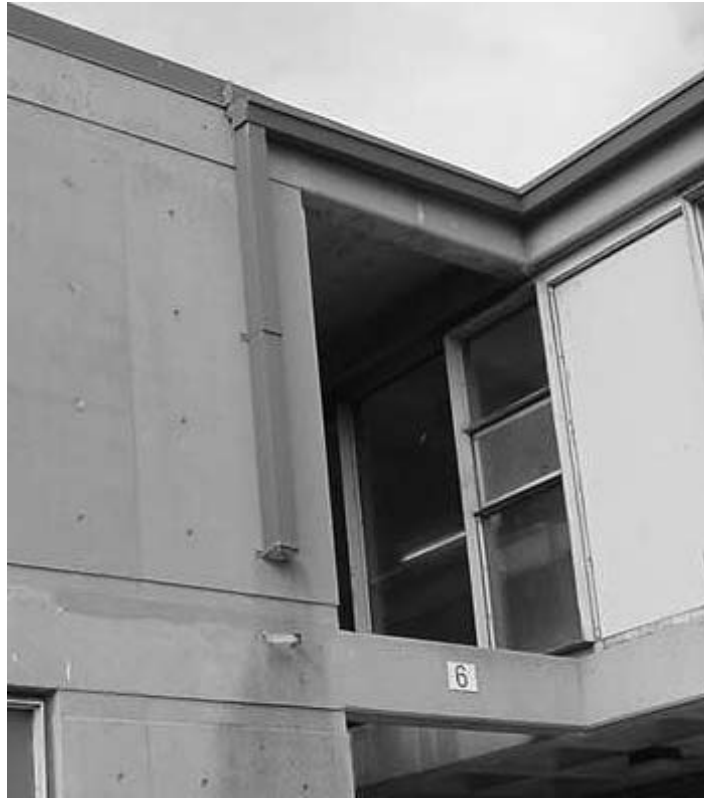
Picture 16

Missing Downspout, Note Water Staining on Wall

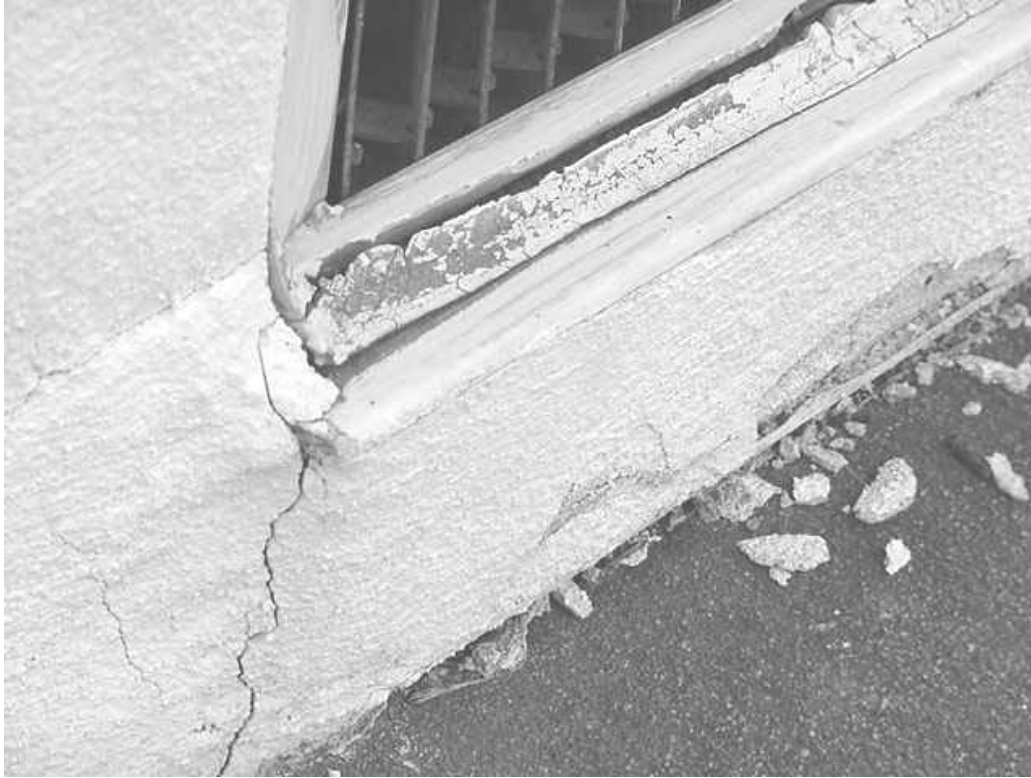
Picture 17

Cracks in exterior walls and crumbled damaged caulking around univent air intakes were noted on the exterior of the building (see Pictures 17 & 18). These breaches in the building envelope can also be potential sources of water penetration leading to water damage and or microbial growth to porous materials.

Crack in Exterior Wall, Spaces around Dried out Caulking Univent Air Intake

- 7. Take measures to prevent water intrusion through the building envelope. This may include sealing cracks along the foundation/exterior walls, repairing damaged brickwork and sealing around univents and wall/foundation junctions with an appropriate sealing compound.

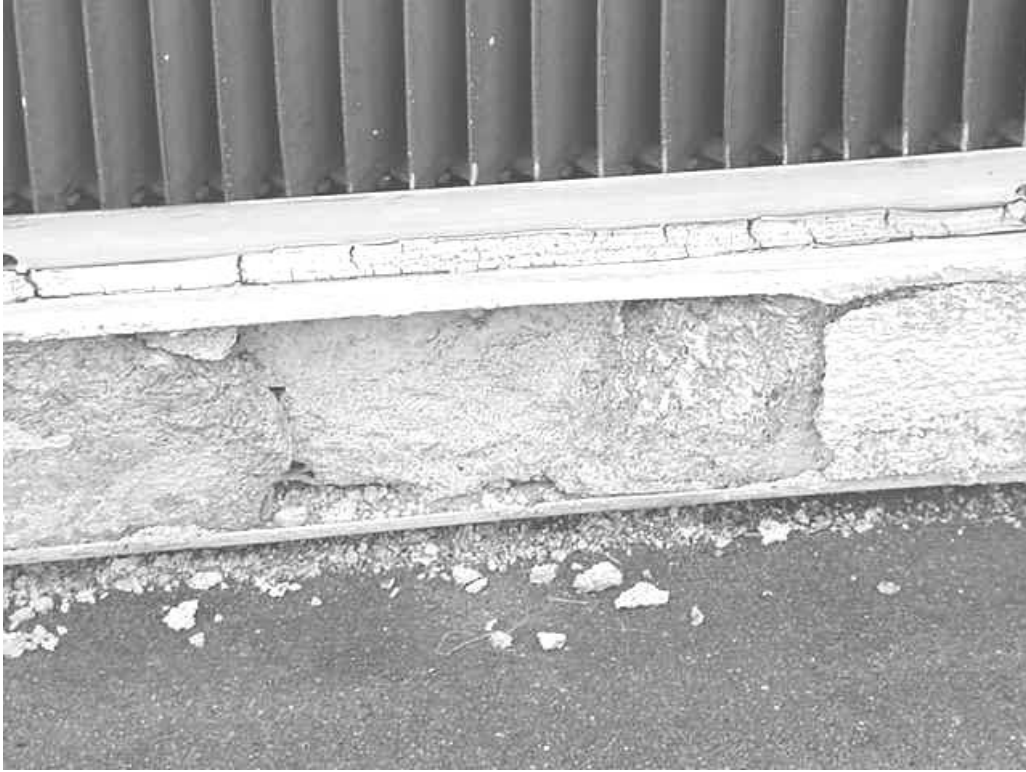
Picture 18

Damaged Exterior Wall, Dried Out/Crumbling Caulking Around Univent Air Intake

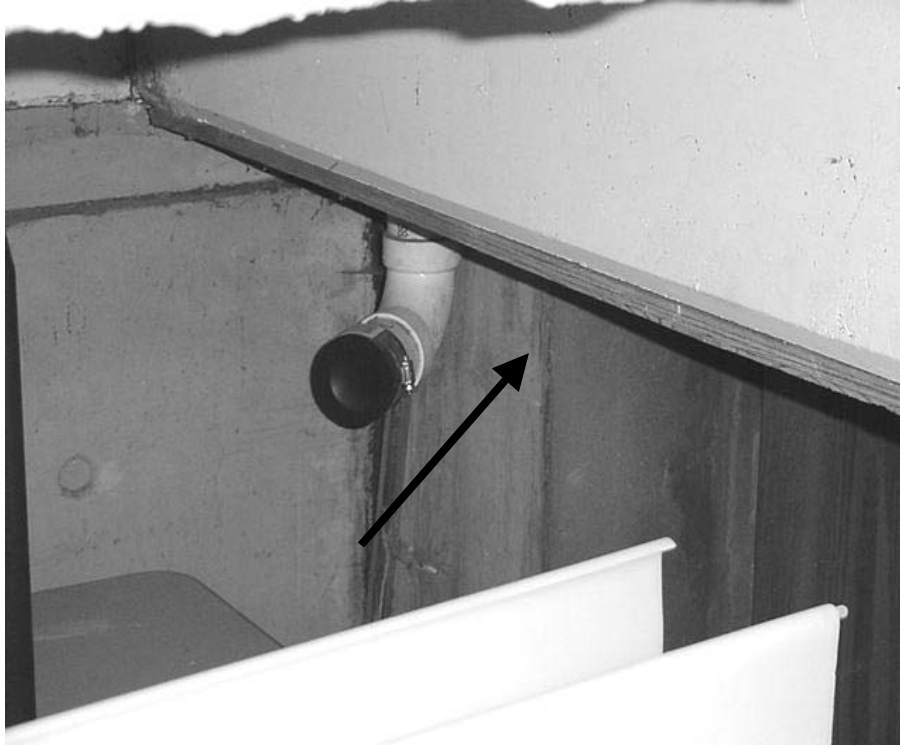
Picture 19

Several other conditions were noted during the assessment, which can affect indoor air quality. Of note was the detection of airflow from seams between walls beneath the stairwell to the south wing (see Picture 19). Similar airflow from holes around retrofitted HVAC system pipes were noted in a classroom that shares the stairwell wall (see Picture 20). This airflow was traced to a crawlspace that connects to the boiler room. This crawlspace was dry and no odors were detected by BEHA staff within the crawlspace. As part of the remediation of the boiler room, improved make up air vents to aid boiler combustion were rehabilitated. The opening to the crawlspace exists in the boiler room (see Picture 21). A northwest wind was detected by BEHA staff, which enters the boiler room, pressurizes the area, and creates drafts in the crawlspace which

forces air through the seams noted beneath the stairwell and in the classroom.

Seam in Walls beneath South Wing Stairwell

- 8. Seal wall seams beneath the stairwell and pipe penetration from the crawlspace.
 - 9. Construct a wall over crawlspace entrances in the boiler room.

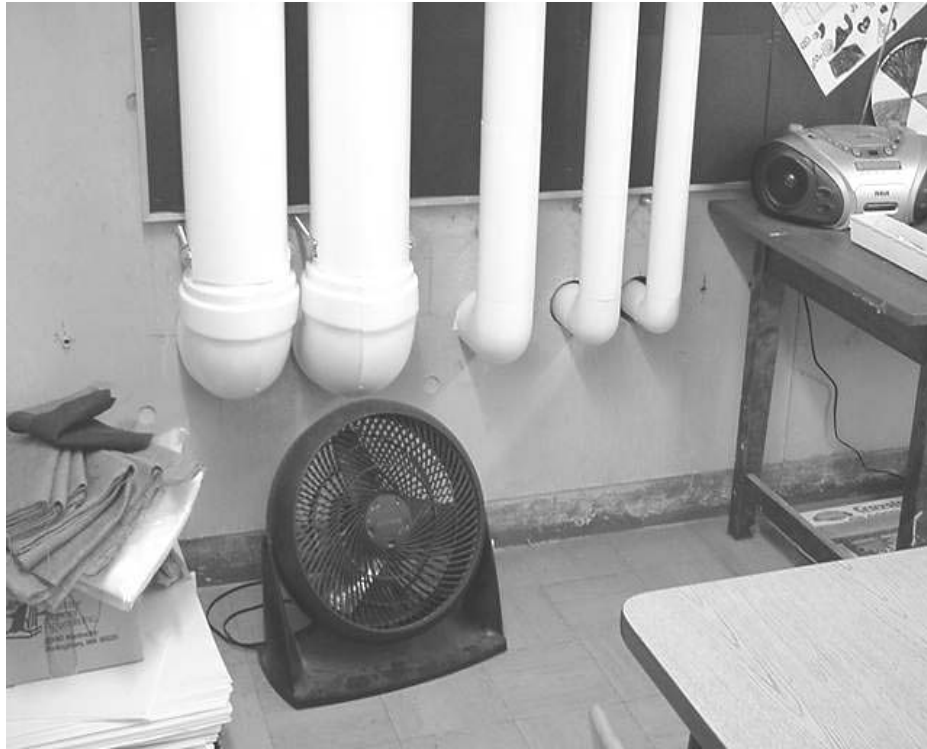
Picture 20

Spaces around HVAC System Pipes

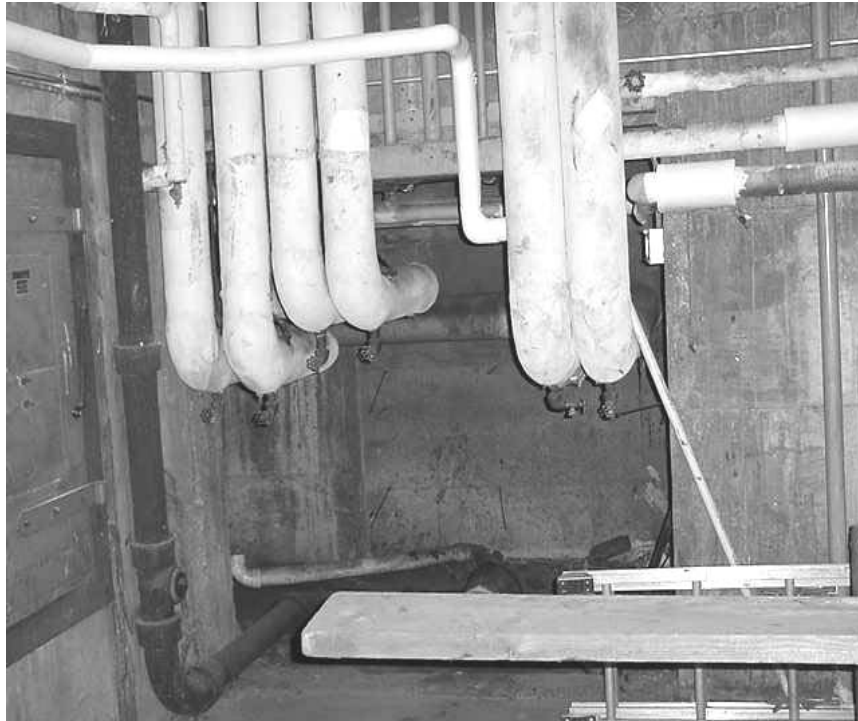
Picture 21

Opening To Crawlspace in Boiler Room

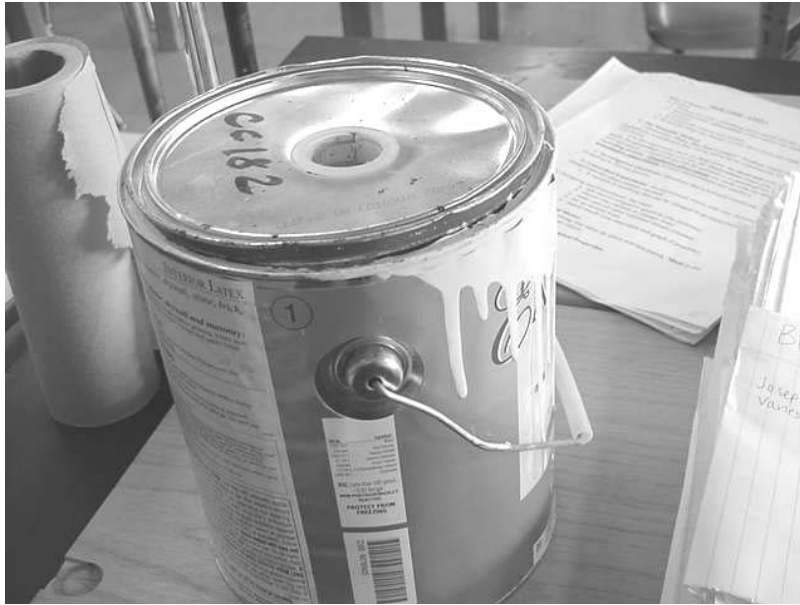
Picture 22

Finally, a can of latex paint was stored in a cabinet at the front of the classroom. The can was not properly sealed which can allow off-gassing paint fumes and volatile organic compounds (VOCs) into the classroom (see Picture 22), providing a source of eye and respiratory irritation.

Latex Paint Not Properly Sealed Found In Classroom Cabinet

- 10. Have a complete inventory done in all storage areas and classrooms. Discard hazardous materials or empty containers of hazardous materials in a manner consistent with environmental statutes and regulations. Follow proper procedures for storing and securing hazardous materials. Obtain Material Safety Data Sheets

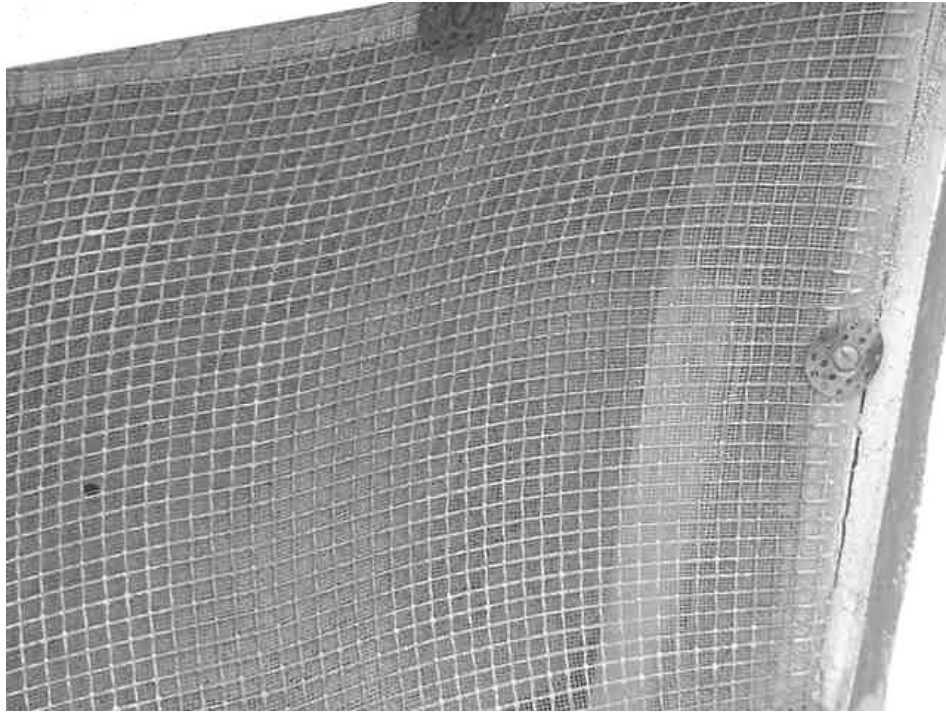
Picture 23

Wire Mesh Screen Installed over Univent Fresh Air Intake
